Retaining Wall and Road

Carlton Gore Road

Summary of heritage significance

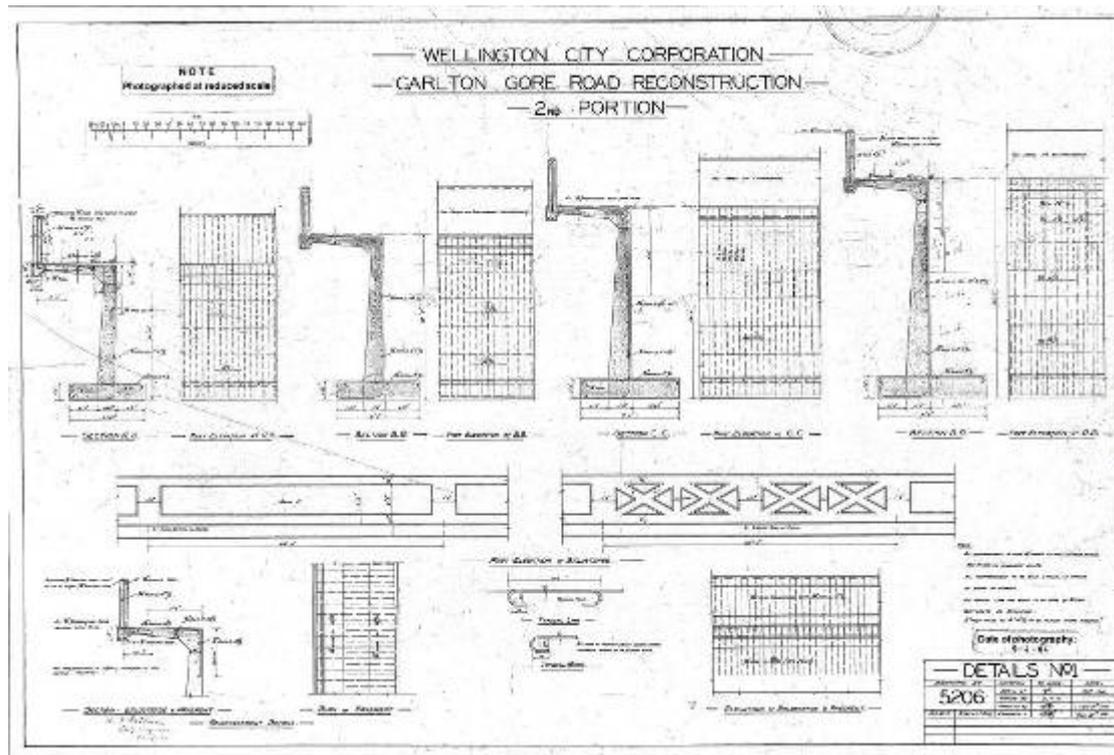
1.2 Timeline of modifications (original plans – more available in building file)

1925-1930 Construction

The first length of the retaining wall was constructed in reinforced concrete, the wall being on the outer edge of the twenty four foot roadway and a six foot footway. The next lengths were to be constructed in the main, either with piers supporting the footway above the cliff face and no actual wall supporting the road way, or with supporting walls and the footway carried out beyond the vertical line of the wall upon a cantilevered platform. The different options were created so that, depending upon the foundations and the steepness of the cliff, one or the other could be adopted based on its suitability.³ It appears that no one option was chosen, and a combination of the different options was used for the road building depending upon the topography. Where the hillside was not too steep walls have been used, where the ground drops away more (and where it would be uneconomic to build an extremely tall wall) piers were used, and in cases where neither piers nor walls were an option the road and walkway was cantilevered out.
