Men's Toilets (Former)

Courtenay Place

Summary of heritage significance

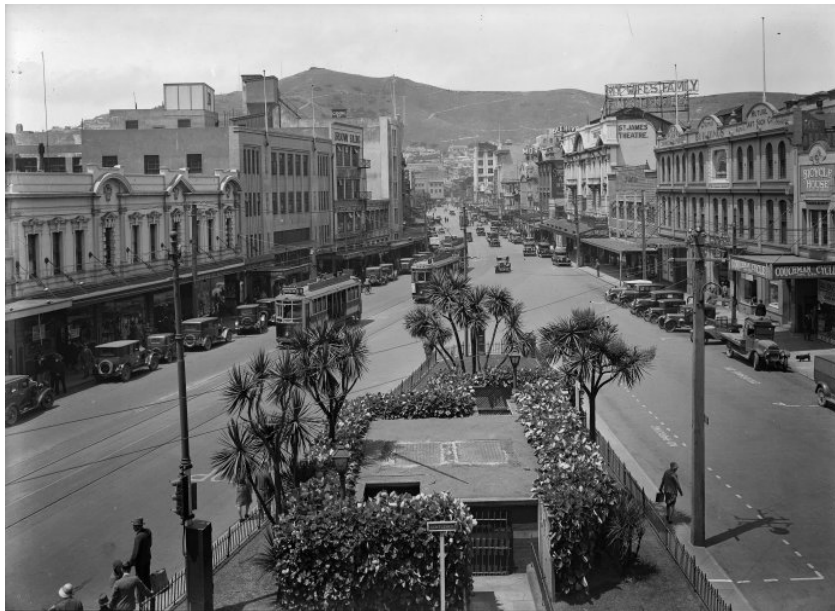
'Courtenay Place 1920-1930', Evening Post :Photographic negatives and prints of the Evening Post newspaper, Reference Number PA-Group-00287

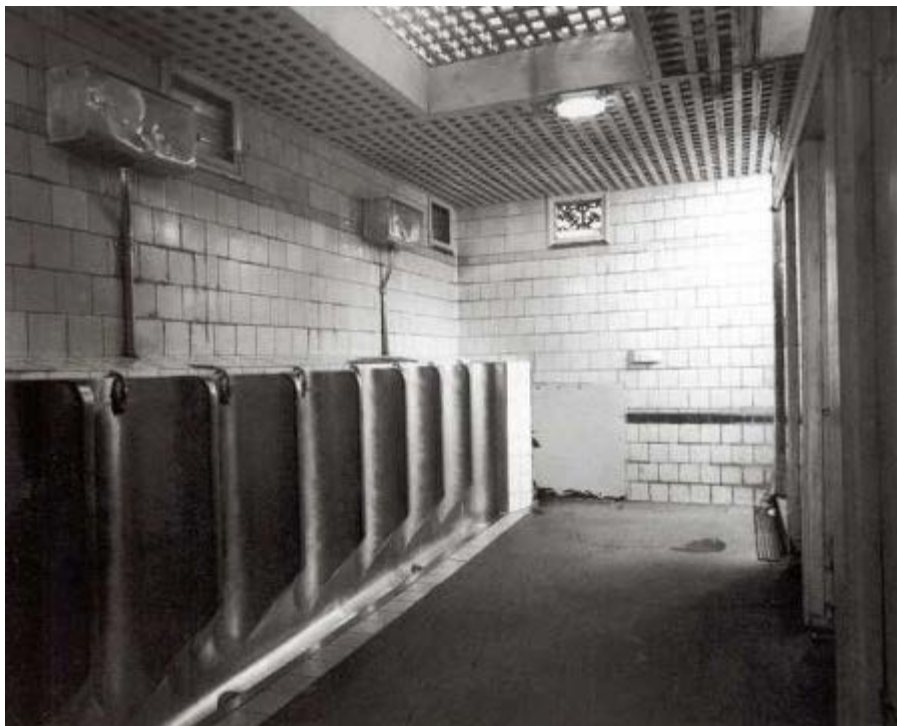
Interior of the Men's Bathrooms 1998, 'Sport 29: Autumn 2001', accessed 15 March 2013, <http://nzetc.victoria.ac.nz/etexts/Ba26Spo/Ba26Spo084a.jpg>
