Bank of New Zealand – Te Aro Branch

79-85 Manners Street, cnr Cuba Street

Summary of heritage significance

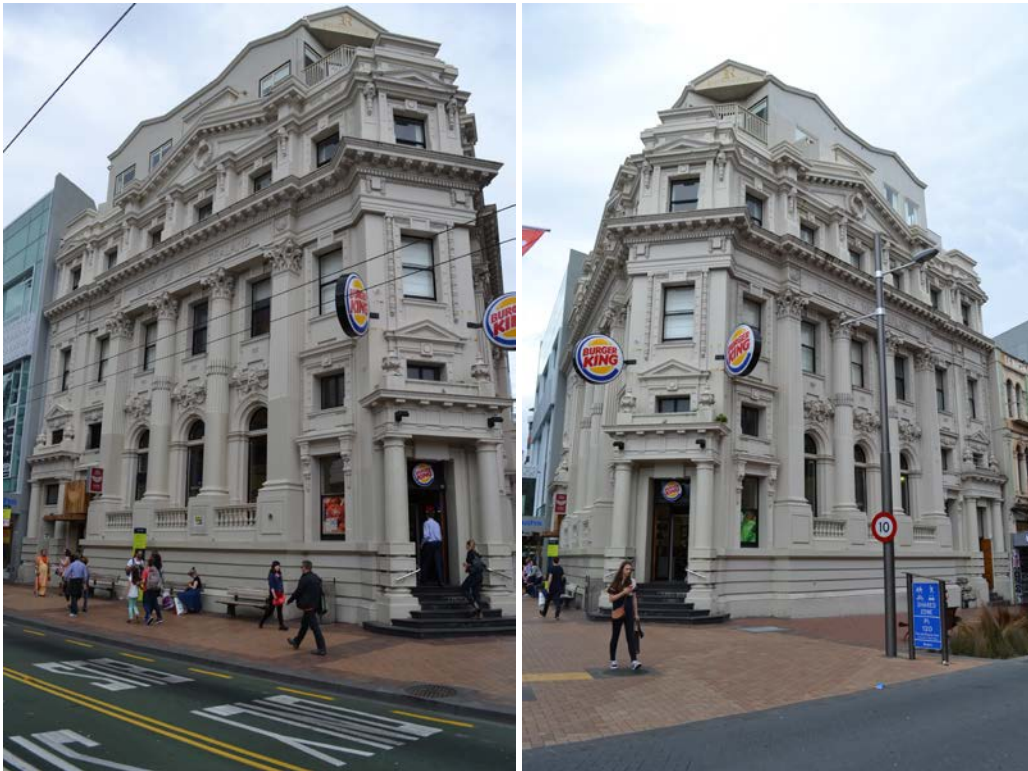
Bank of New Zealand, Te Aro Branch Building. (*Charles Collins, 2015*)

- Designed by prominent architect William Turnbull in 1912, this building has architectural value for its richly-ornamented facade designed in the Edwardian Baroque style, and an impressive banking chamber, largely intact.

- The building has considerable townscape significance, occupying a prominent corner site in what is a major focal point within the city.
- The construction technology used in this building is significant. The technique of using steel framing encased in concrete was advanced for its time and gives the structure distinct technical value in a city where the frequency and strength of earthquakes was a serious challenge to building designers.

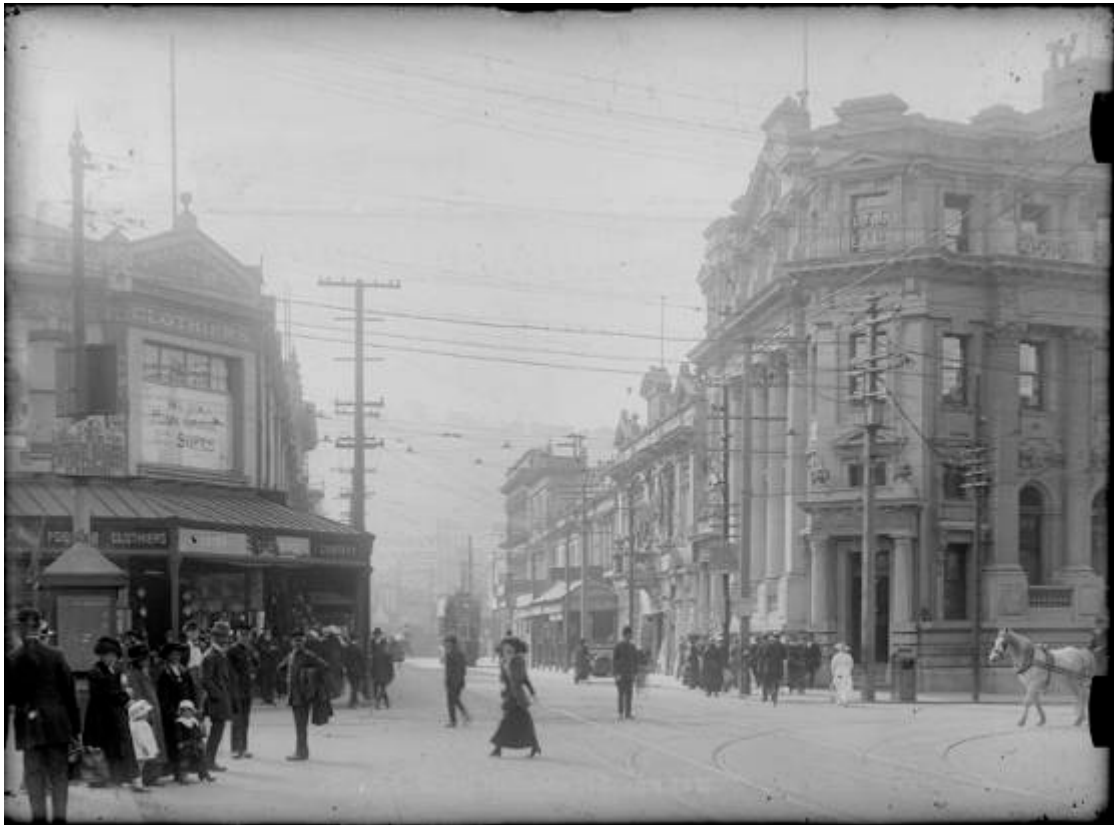
Looking west along Manners Street (centre) from the intersection with Cuba Street (foreground left to right) showing (on the left corner) the Union Clothing Company and (on the right) the Bank of New Zealand. Date unknown. (Sir George Grey Special Collections, Auckland Libraries, 35-R2277).

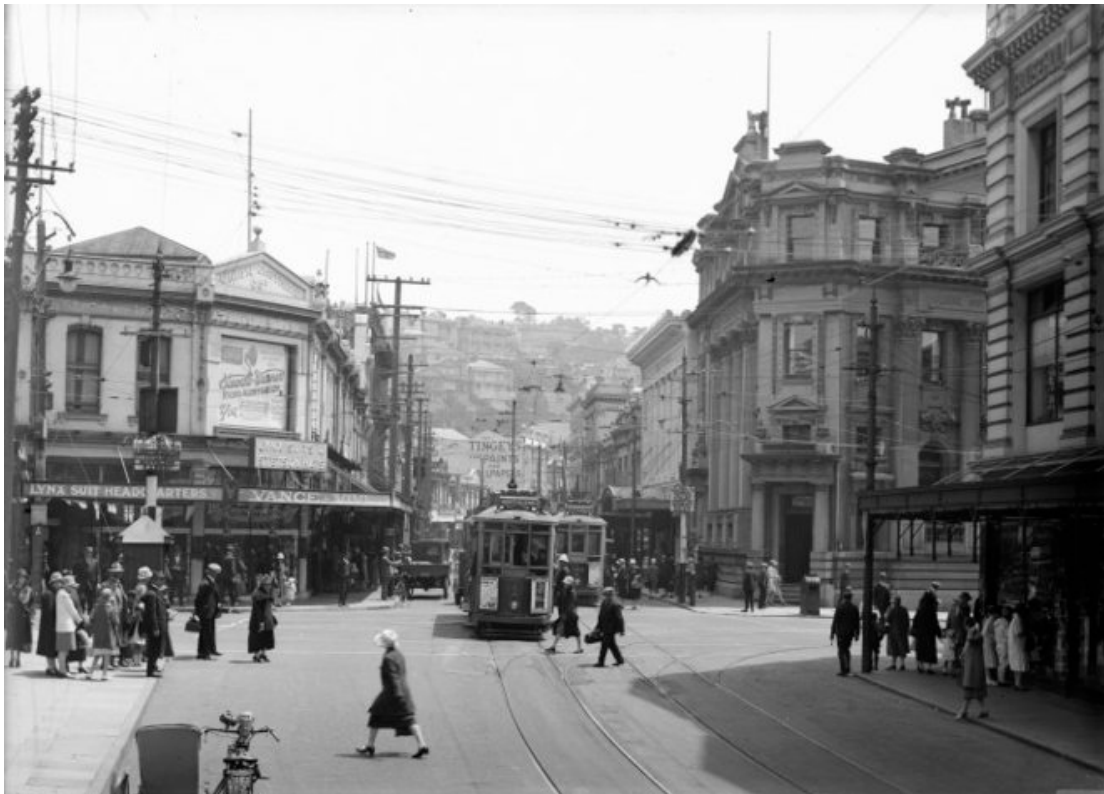
Manners Street, Wellington, circa 1930. Cuba Street is visible. The Bank of New Zealand is on the right and Vance Vivian Ltd, with a sign advertising Lynx suits, is on the left. Photograph taken by Sydney Charles Smith (ATL Ref 1/2-048949-G).
