**Holy Trinity Church**  
639 Ohariu Valley Road

**Summary of heritage significance**

## 1.0 Outline History

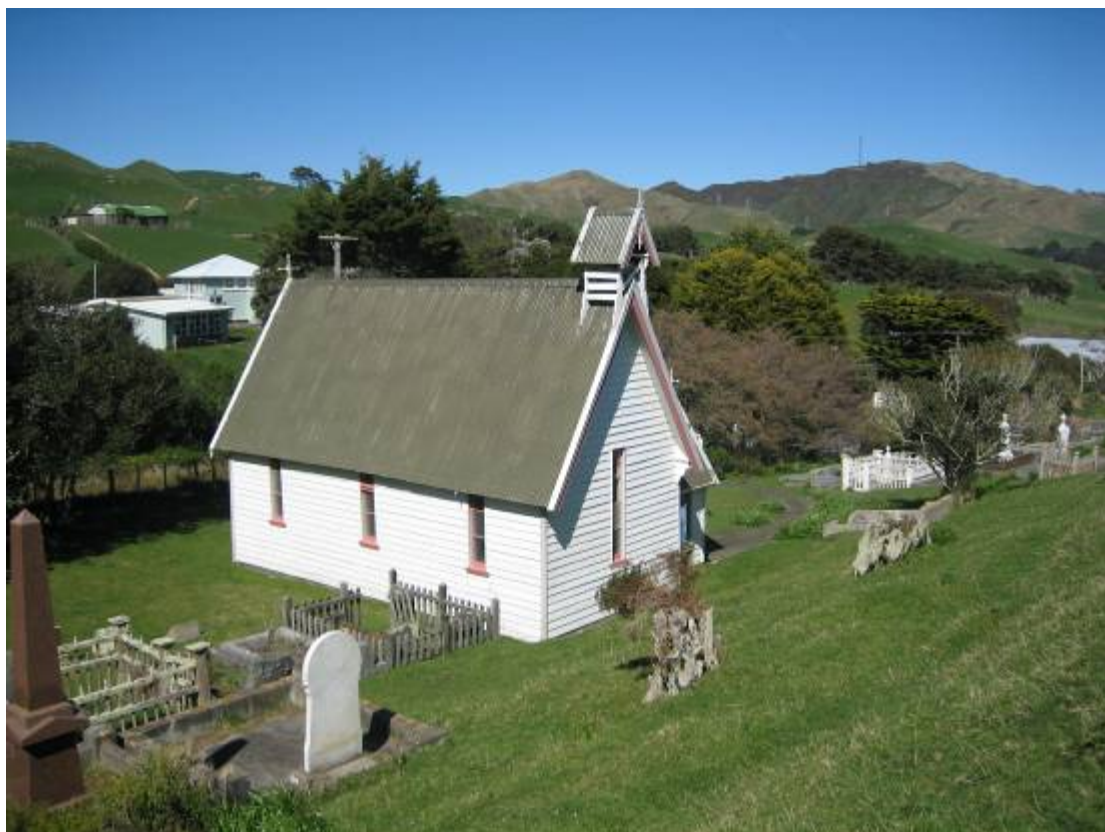
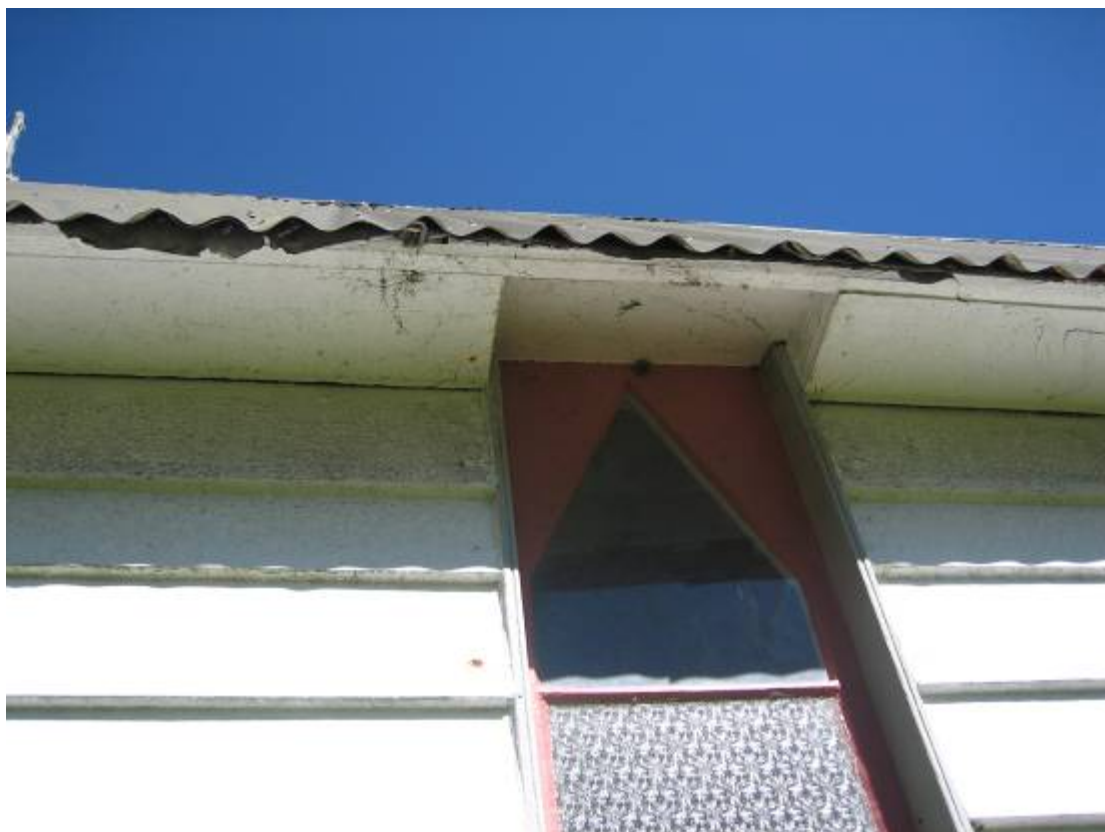
**2011** – North and west elevations of the church taken from the top of the tall bank to the west of the building. Images WCC ref IMG\_6718, IMG\_6715

Holy Trinity church has been built in the plainest and most economical of timber Gothic styles and shows every sign that it was designed by its builder. It is a good example of the adaptability of timber-frame construction, with parts, such as the bellcote, porch and vestry, added and integrated after the initial construction. The plan is a simple rectangle, topped with a steep pitched roof clad in corrugated iron. There is no guttering. The three-part window behind the altar is framed with simple label moulds. An interesting feature is the design of the window heads which have been formed as simple triangles to imitate the pointed arch of traditional Gothic design. On the side elevations the window heads carry up to the top plate and are recessed under the eaves soffit, a practical carpenter's improvisation.

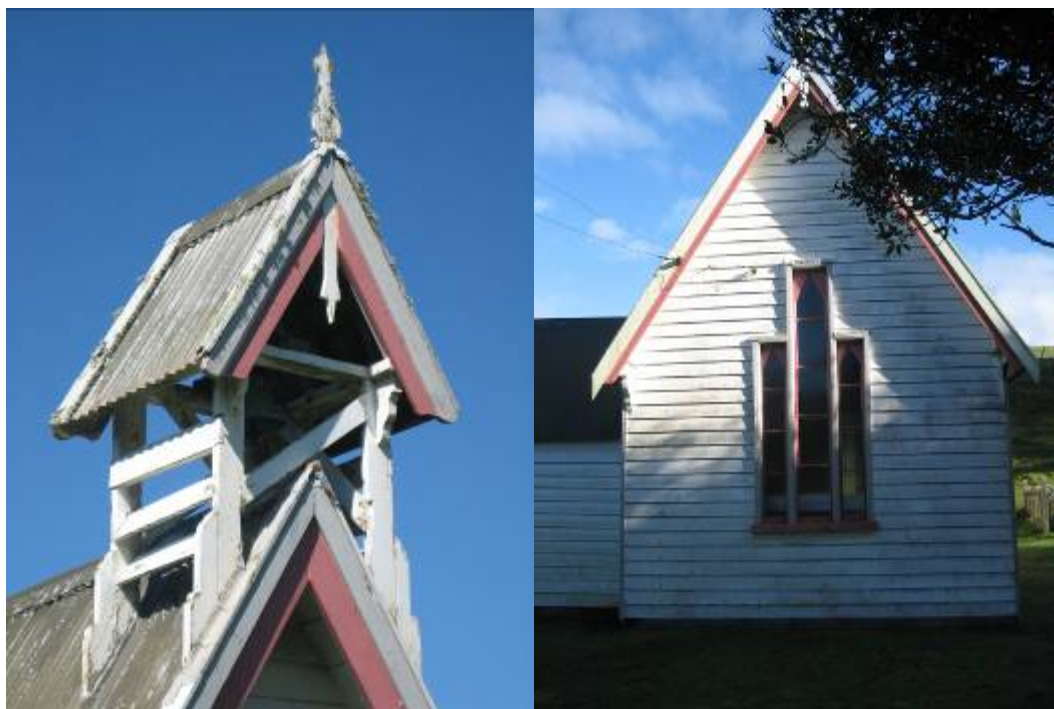
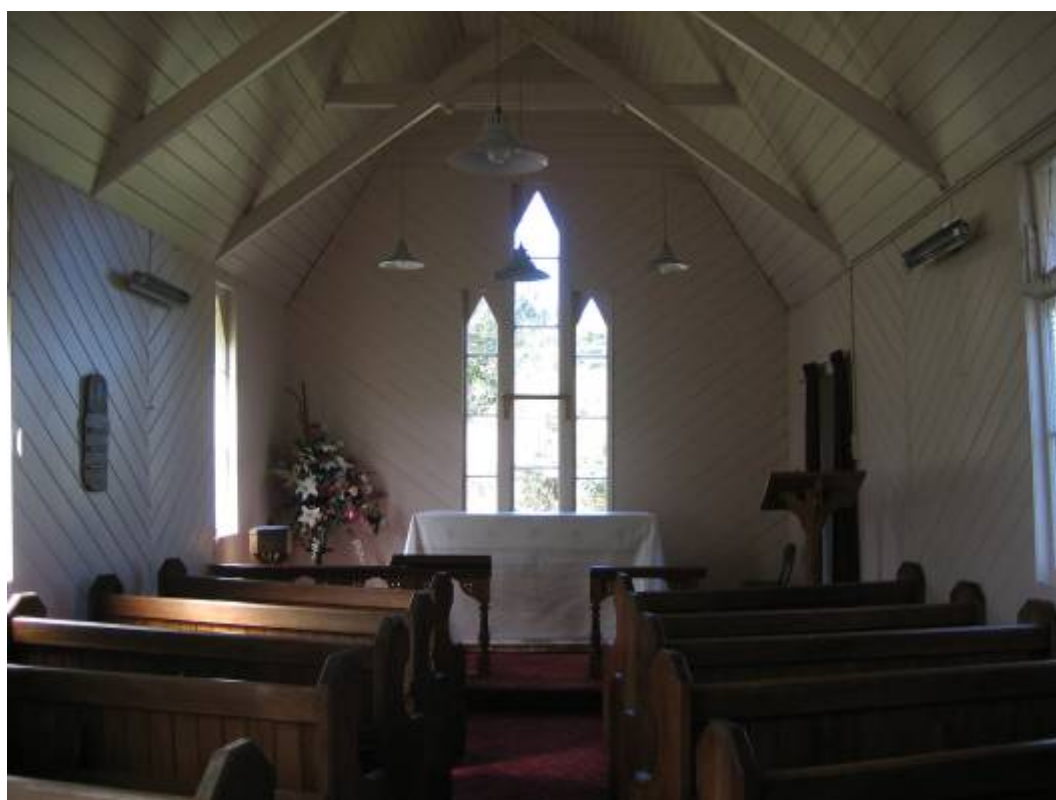
**2011** - Bellcote (top left), east elevation (top right), church interior (bottom). Images: WCC ref IMG\_6726, IMG\_6644, IMG\_6770

Decorative detail is simple and consists of turned brackets at the foot of the gables, the moulding and the profiling of the barge-boards, and a pendant under the gable. The interior is lined in diagonal tongue-and-groove boarding, with a simple truss roof system.
