DIC Redevelopment
For
Wellington Property Consultants

Structural Details
Existing Layout
and Dimensions

Drawing: 250/PO/A
July 84

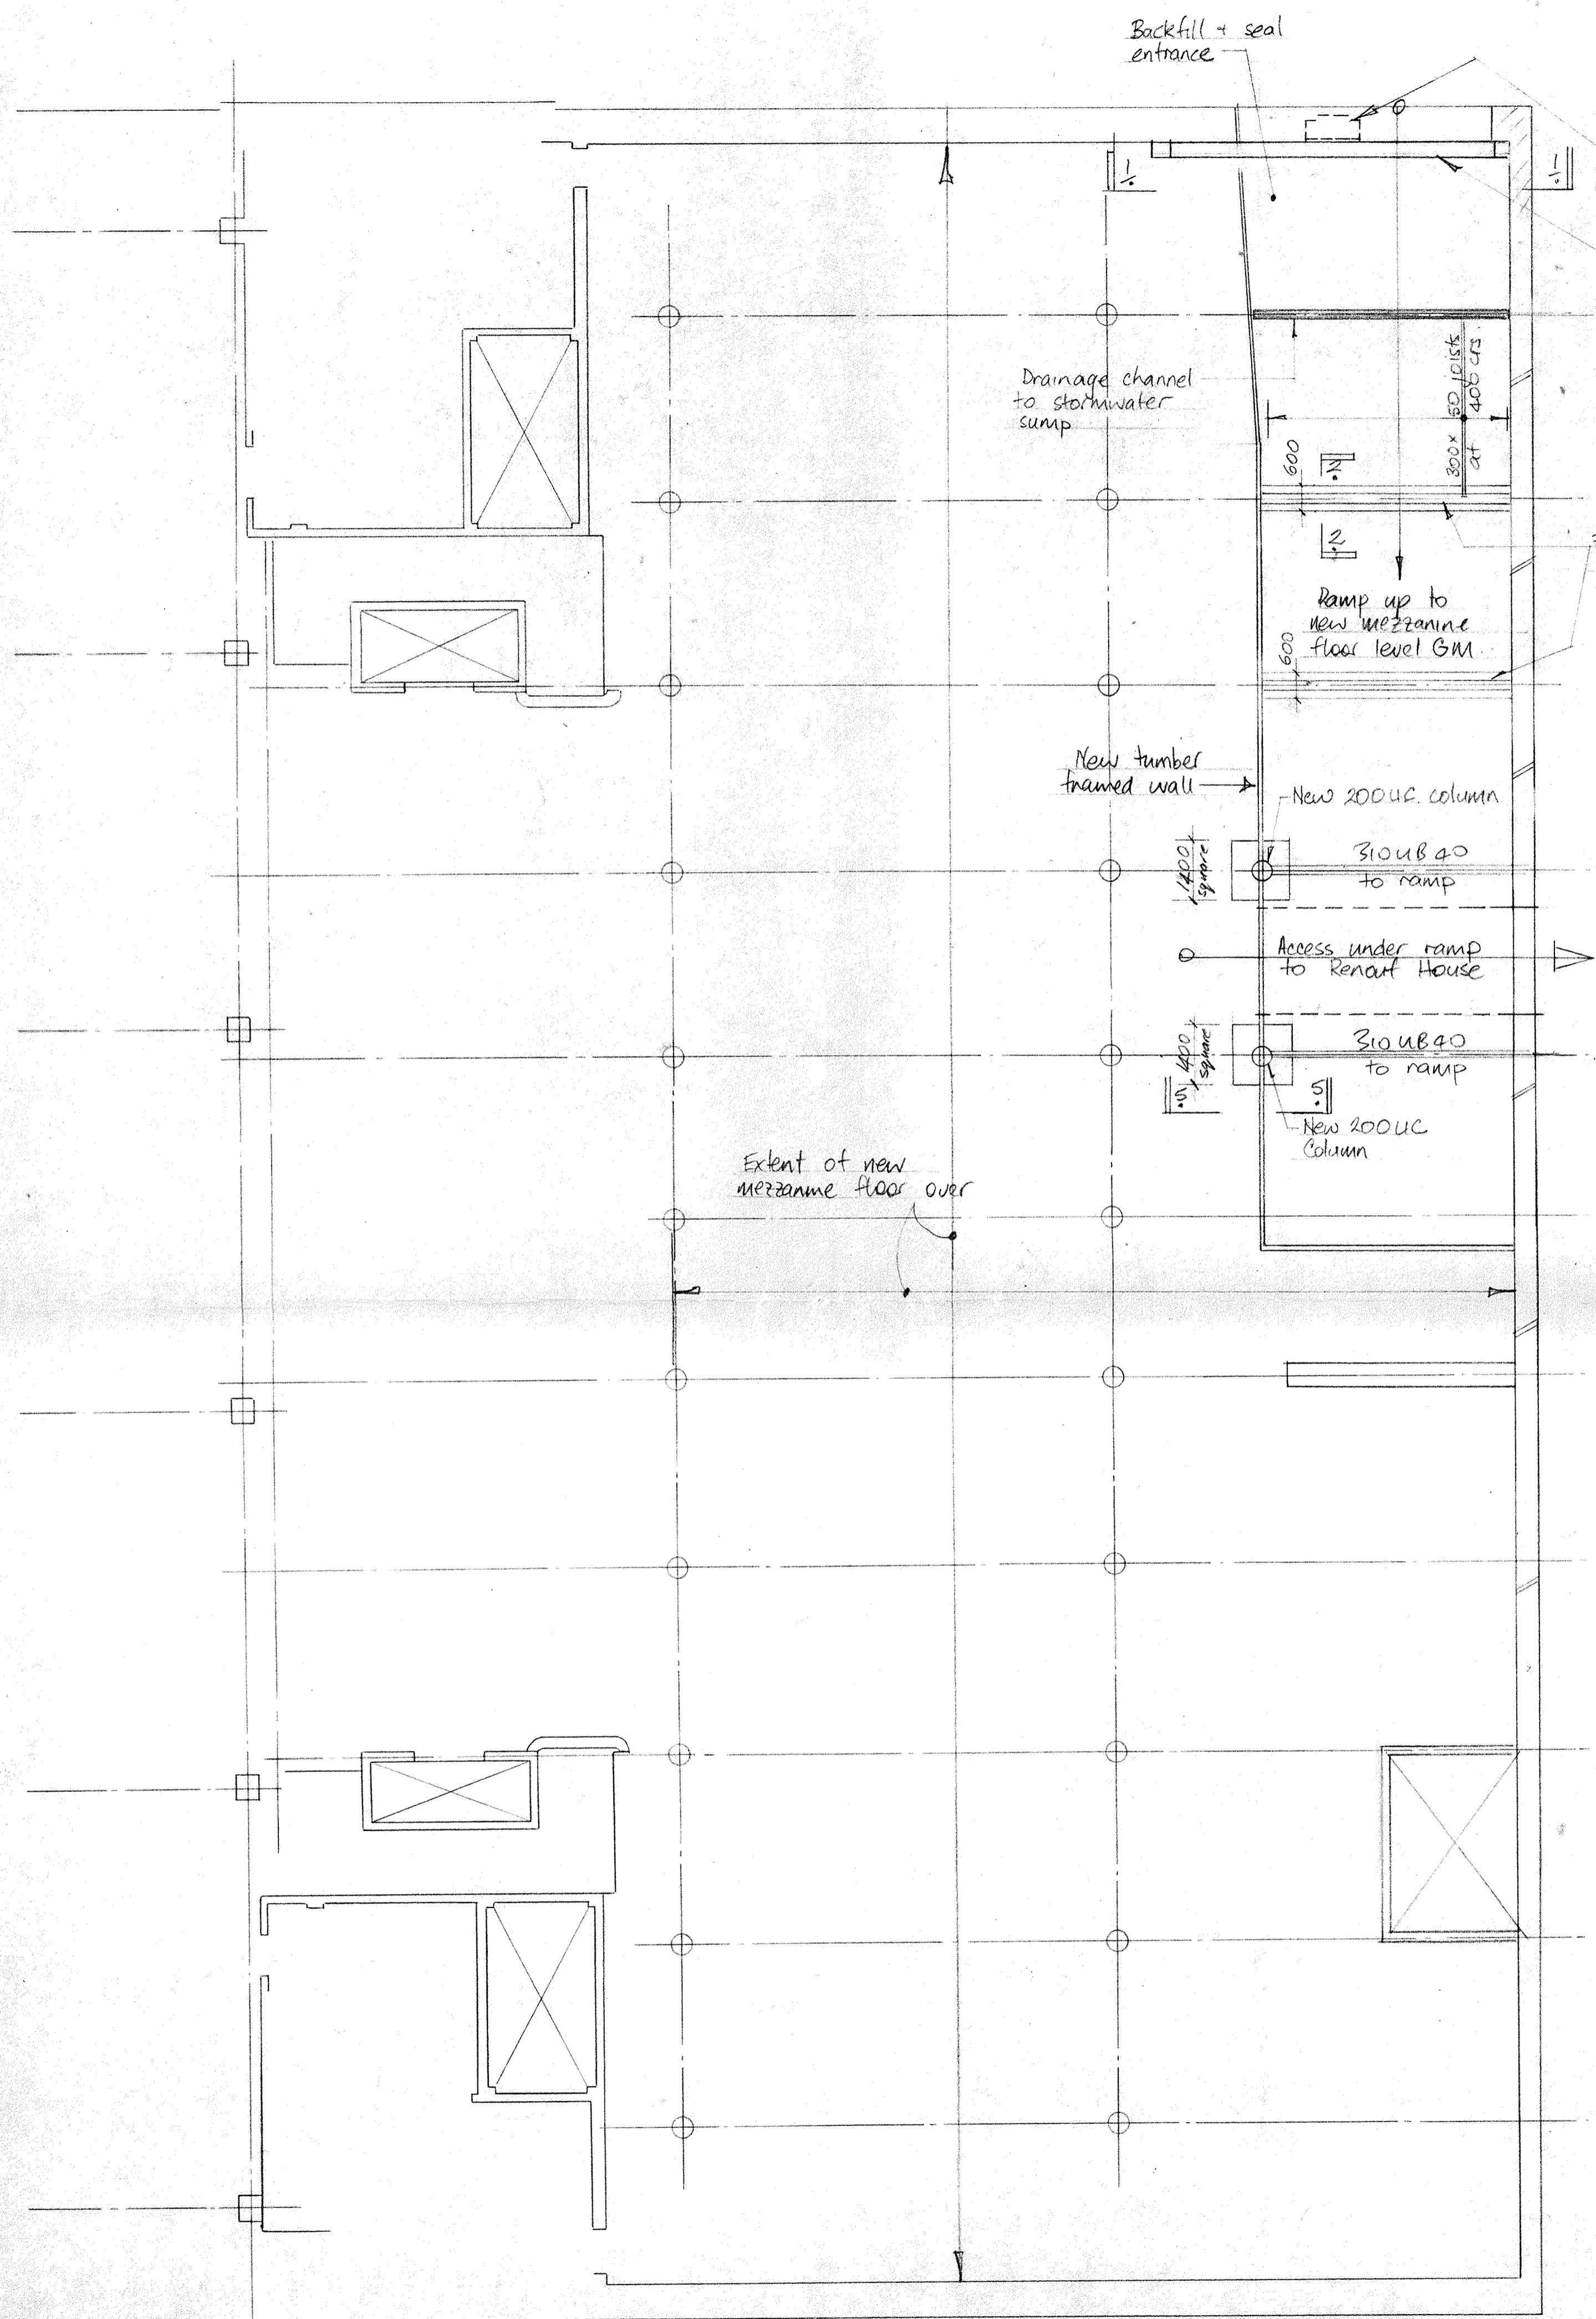
This column removed and replaced by new concrete beam and column span = 8000. New beam at mezzanine floor height

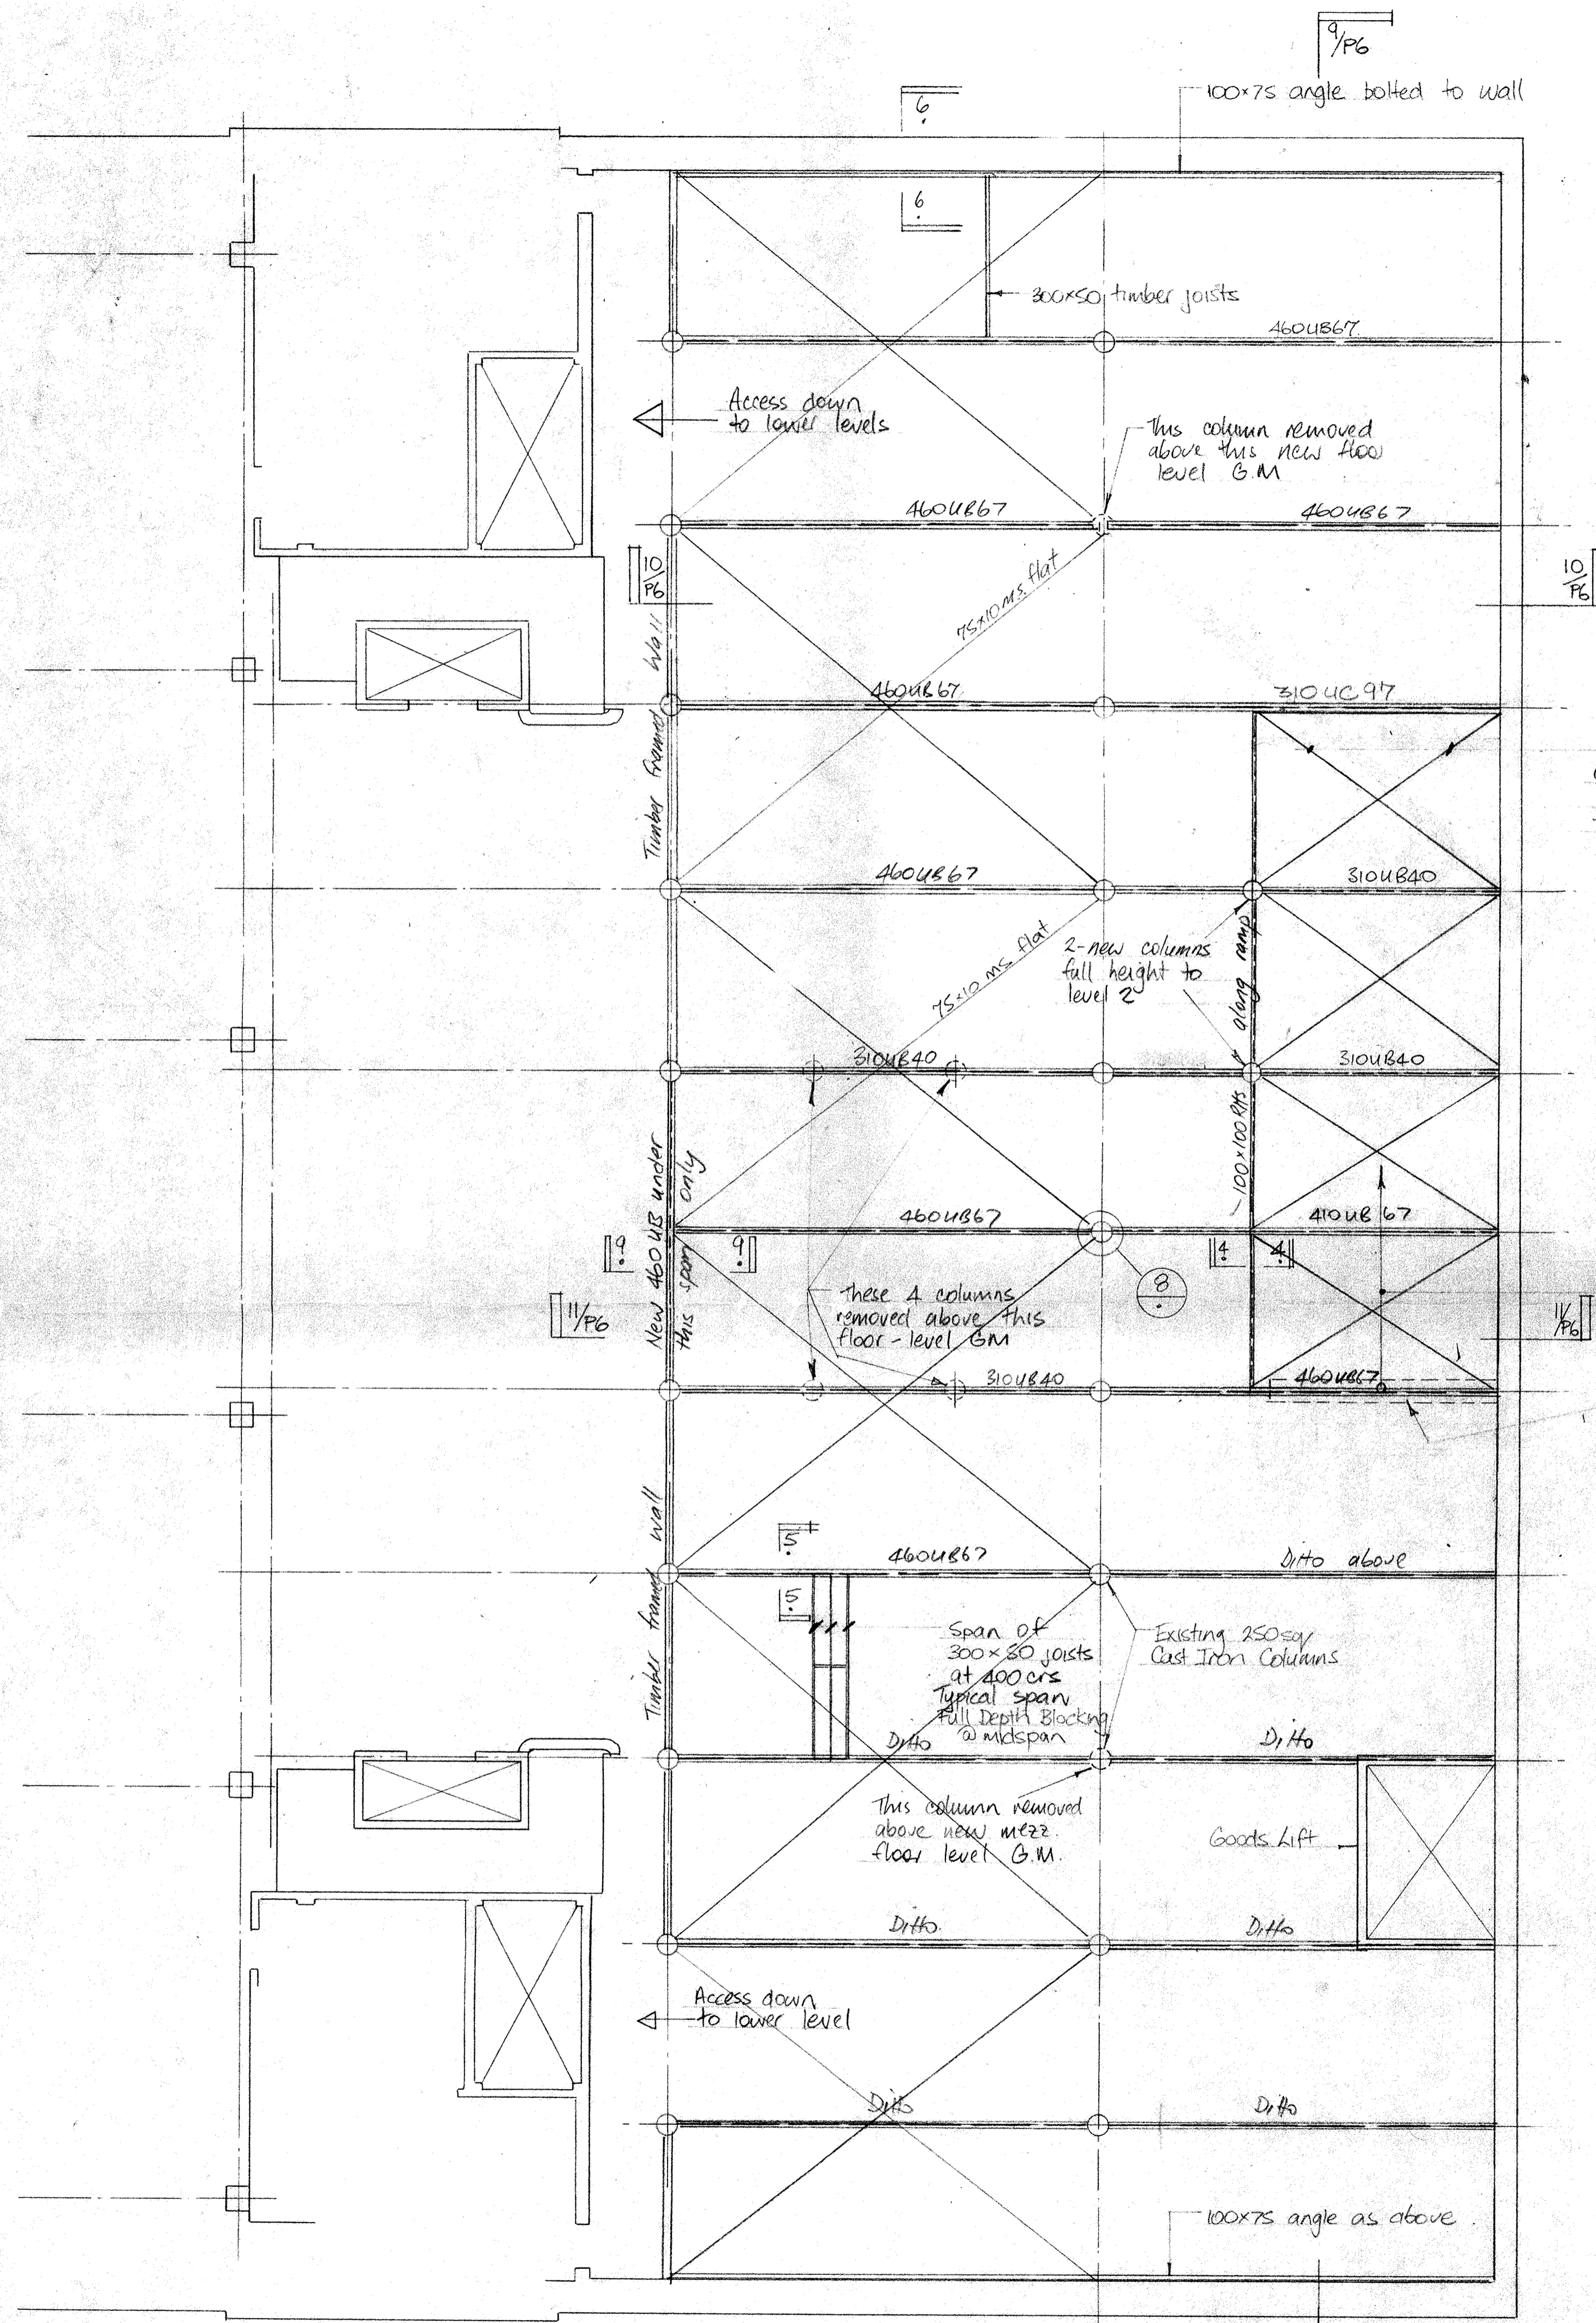
Drawing 250/P1/A
 July 84

Structural Details
 Ground floor Timber Ramp
 to Parking level

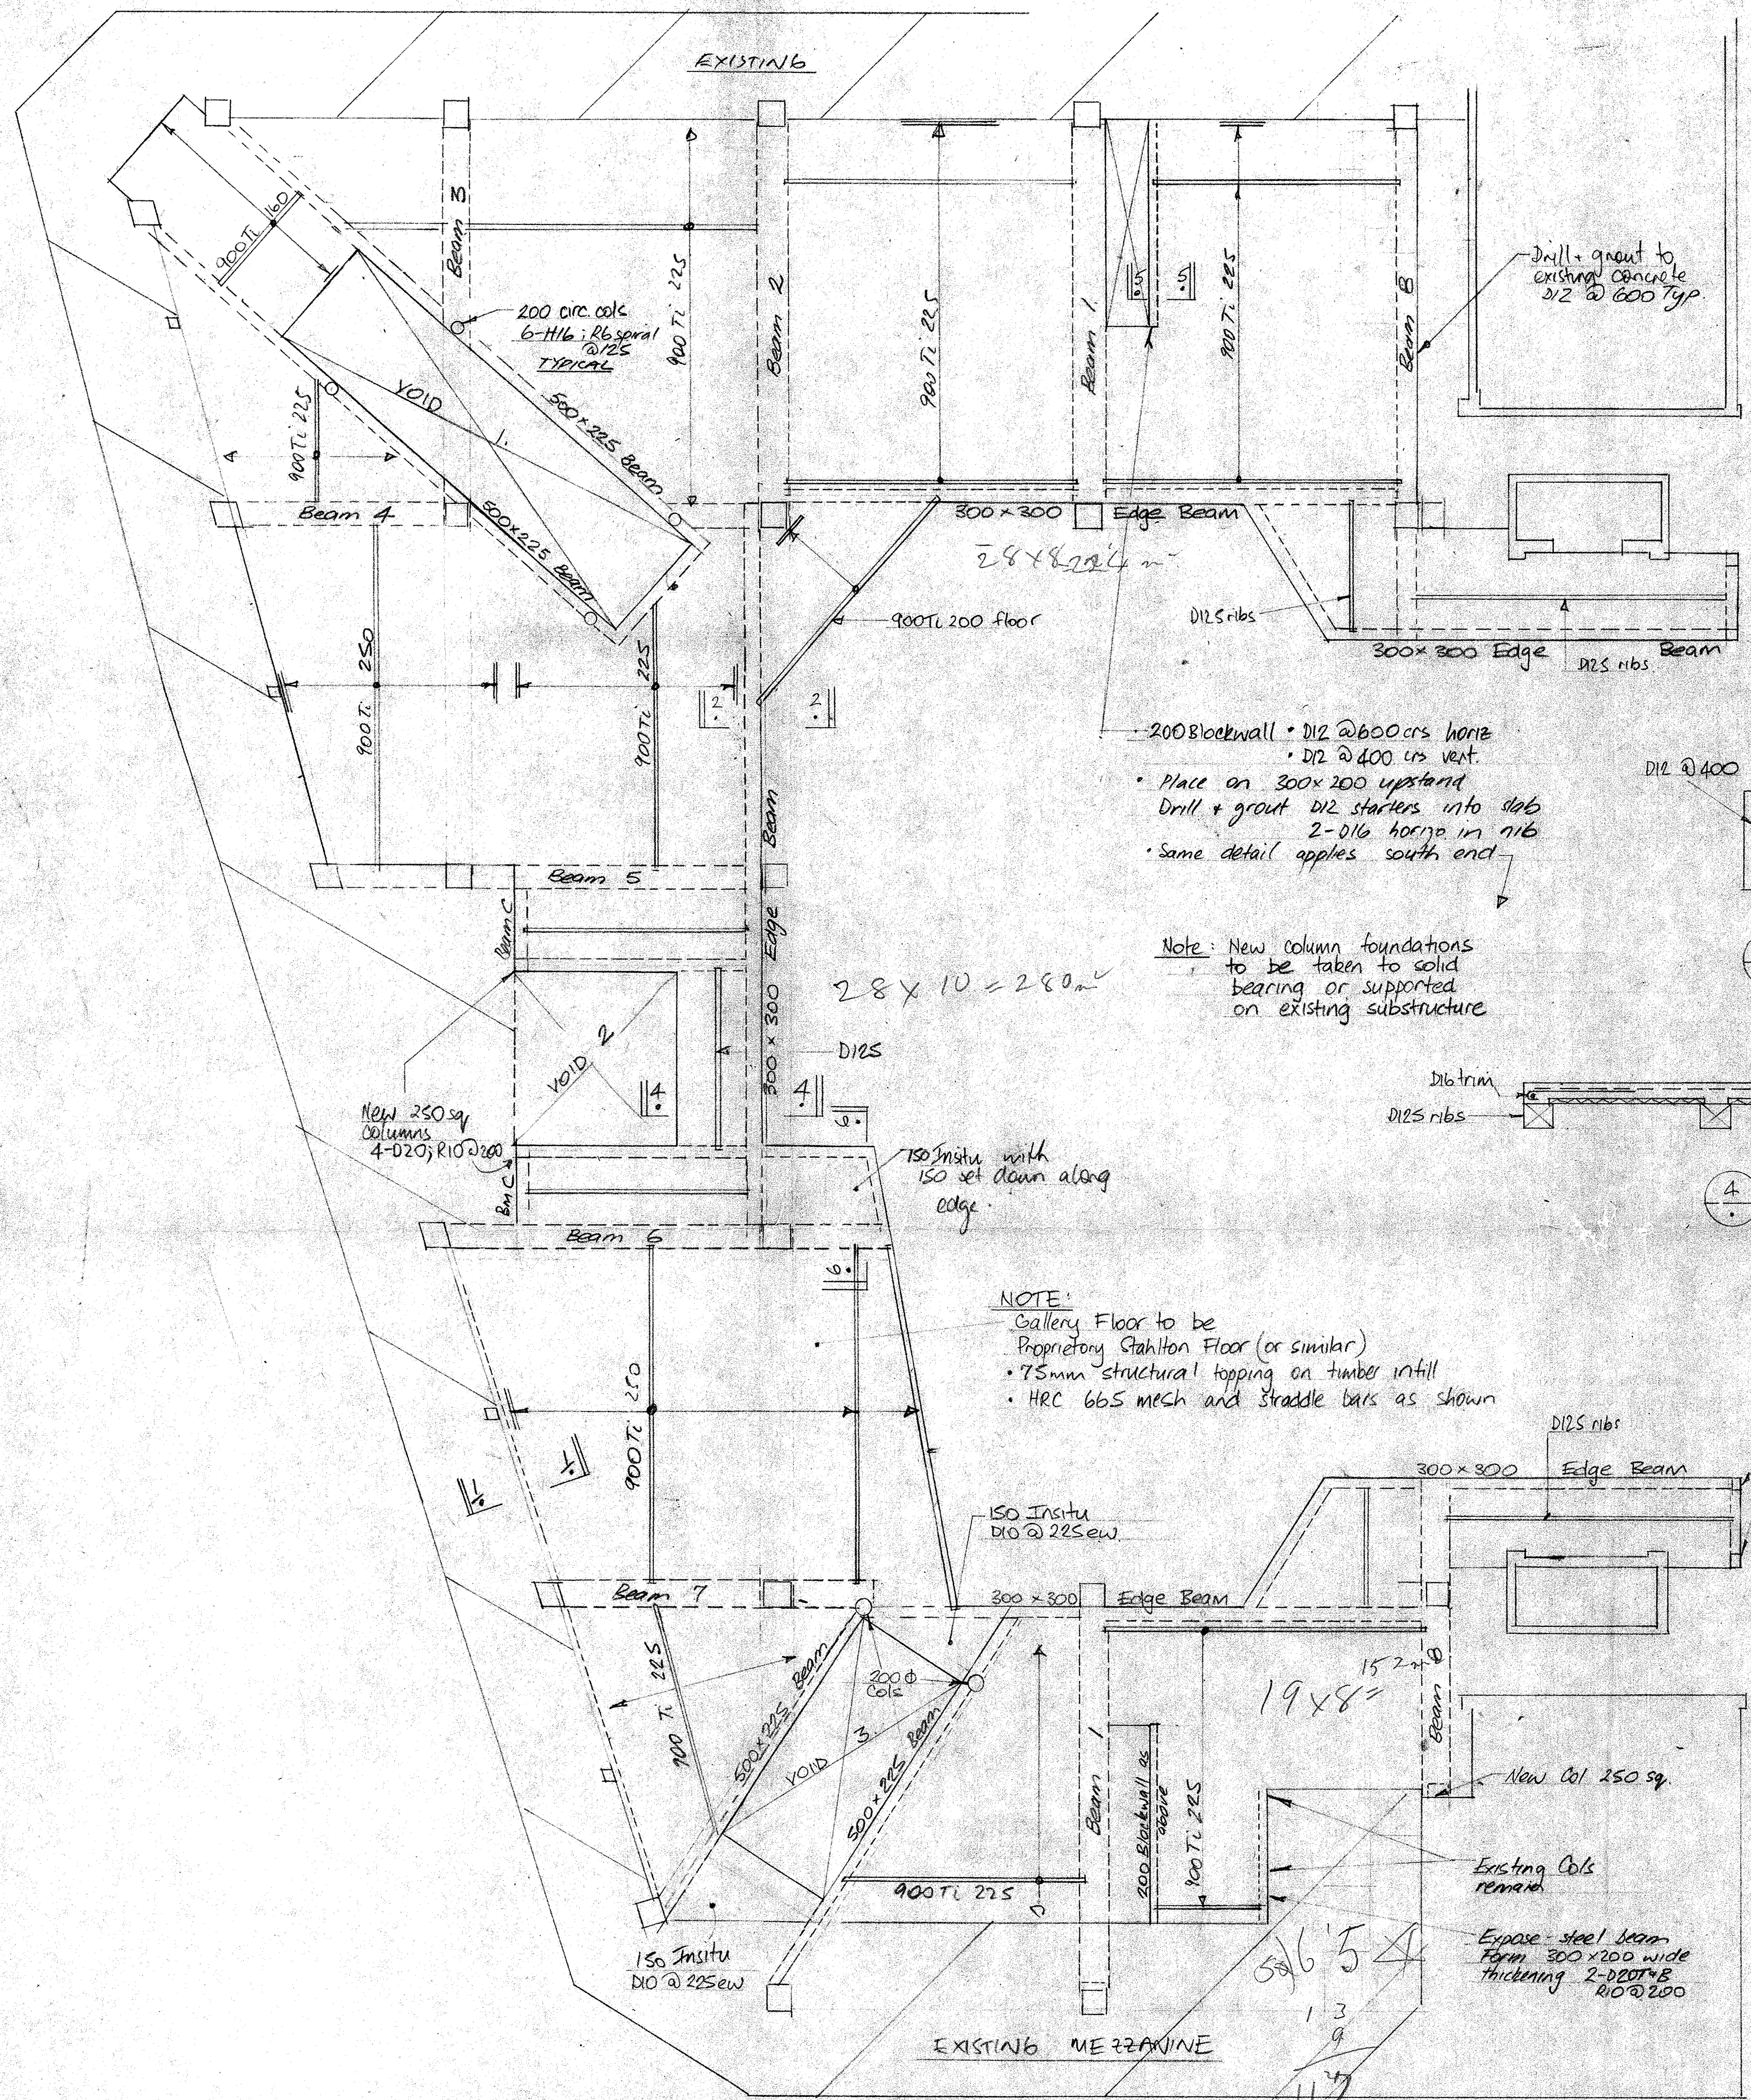
Drawing: 250/P6
July 84

Structural Details
Cross-sections Through
Parking Floor area

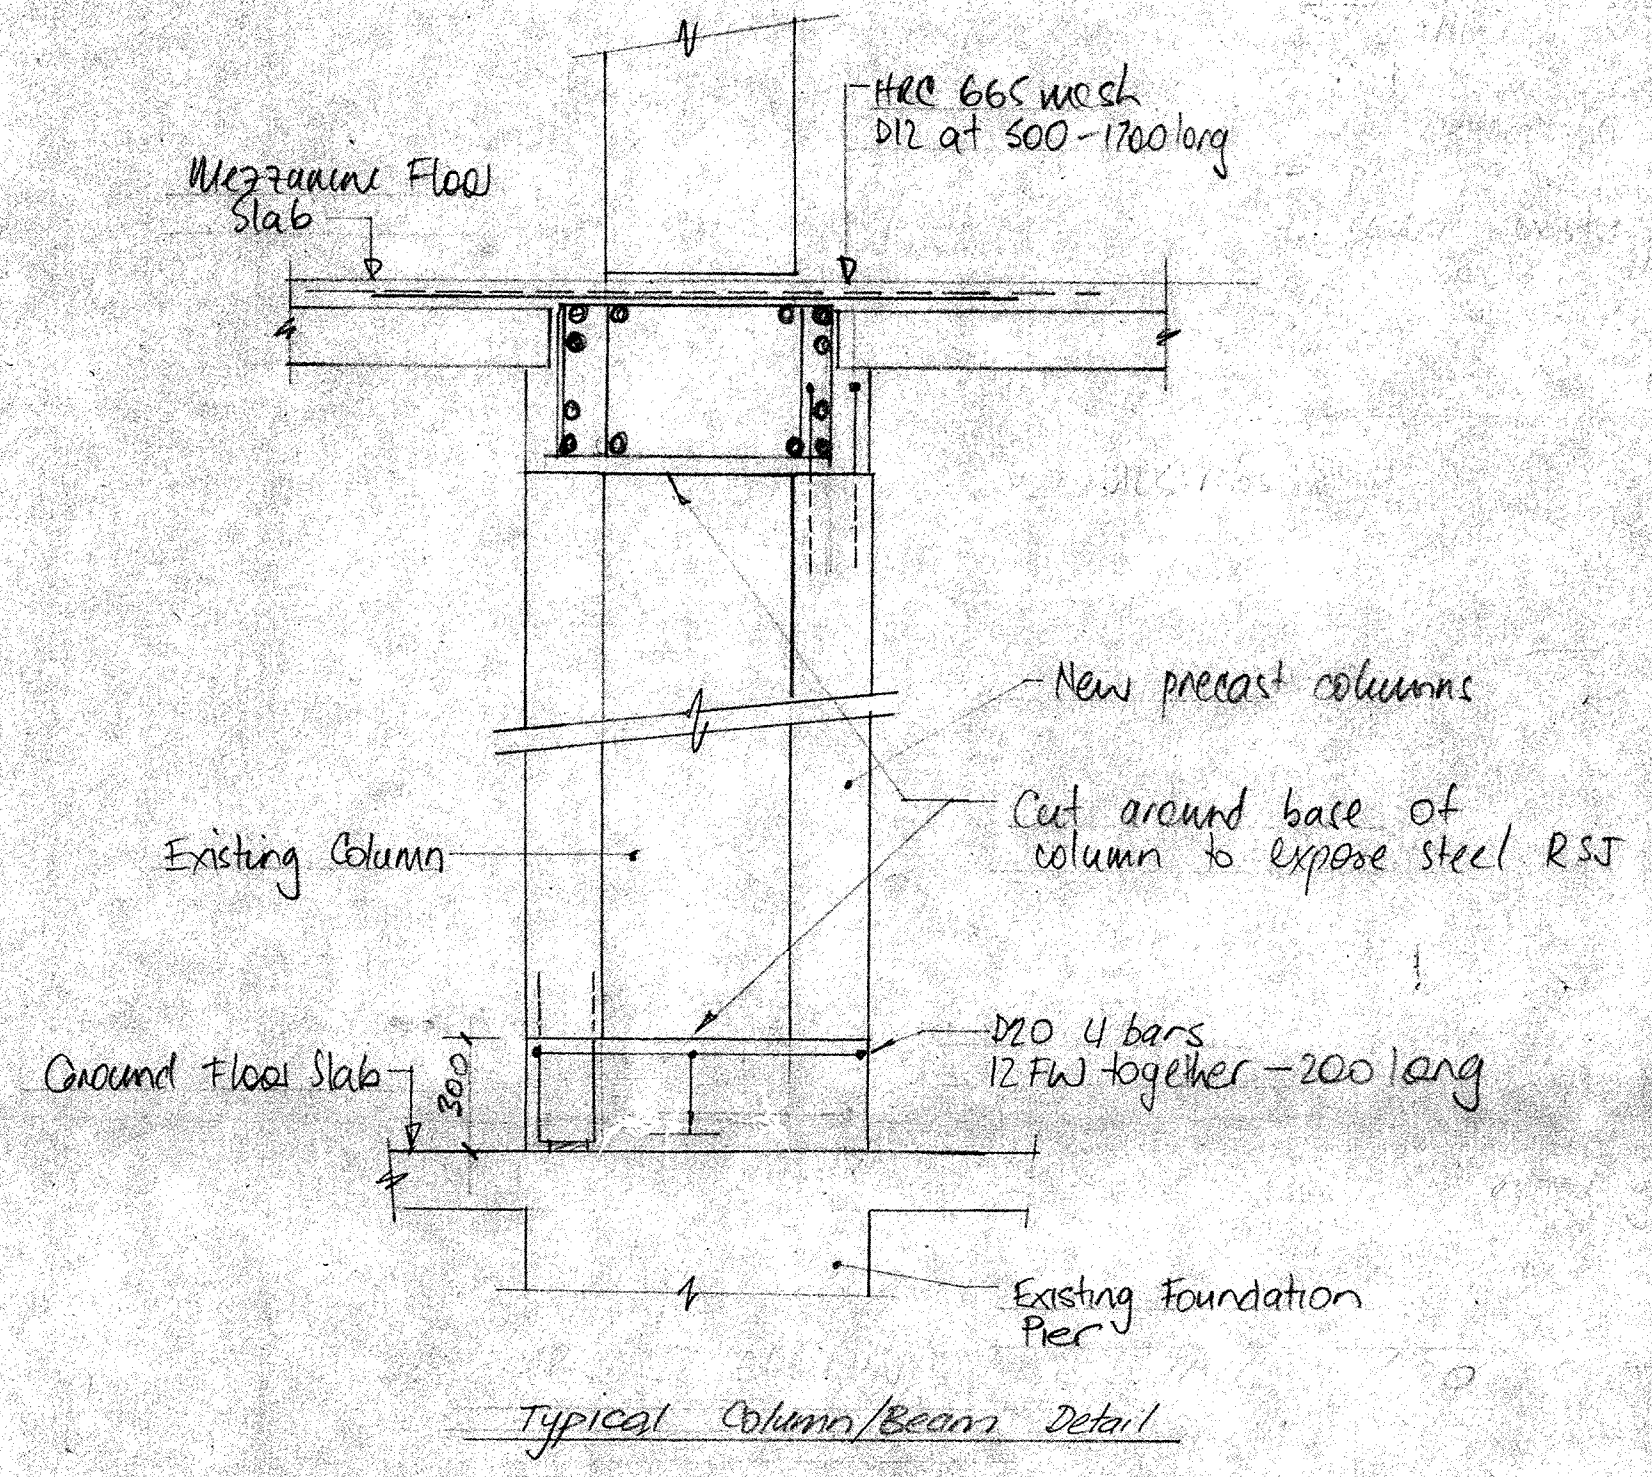
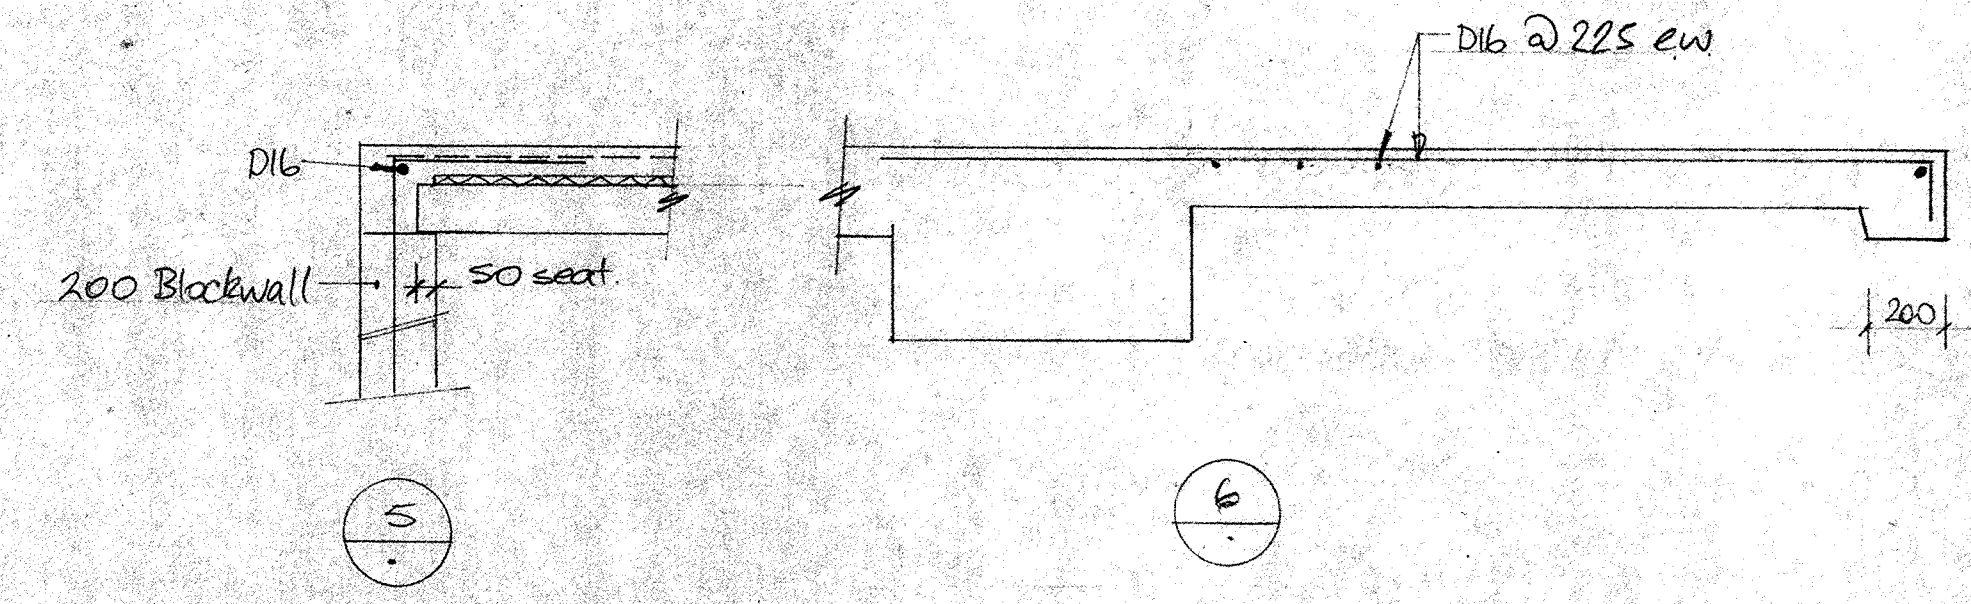
- 200 Blockwall • D12 @ 600 crs horiz
- D12 @ 400 crs vert
- Place on 300x200 upstand
- Drill + grout D12 starters into slab
- 2-D16 horiz in rib
- Same detail applies south end

Note: New column foundations to be taken to solid bearing or supported on existing substructure

- NOTE:
- Gallery Floor to be Proprietary Stahlton Floor (or similar)
 - 75mm structural topping on timber intill
 - HRC 66S mesh and straddle bars as shown

Structural Details
Gallery Floor Slab Plan

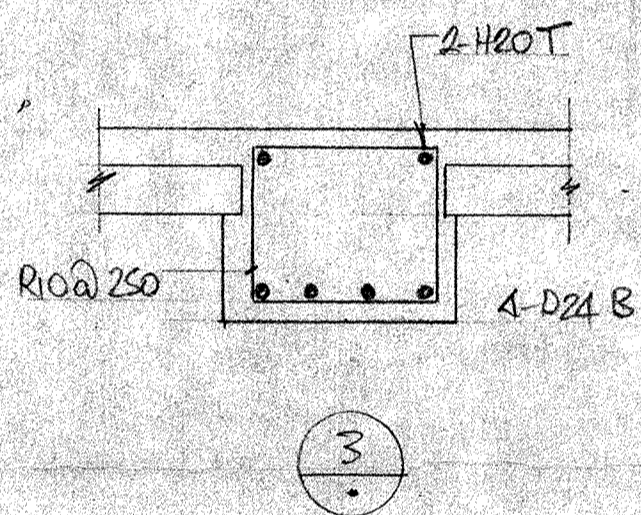
Section Through Typical VOID BEAMS

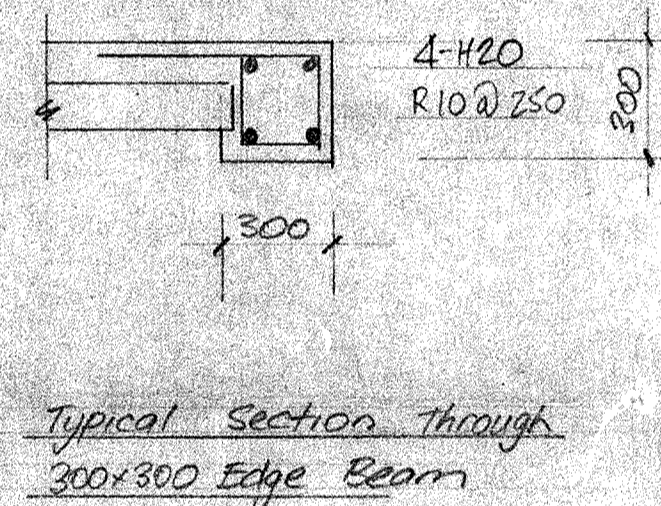
Typical Section Through 300x300 Edge Beam
