Lyll Bay Sea Wall

Lyll Parade, Wellington

Summary of heritage significance

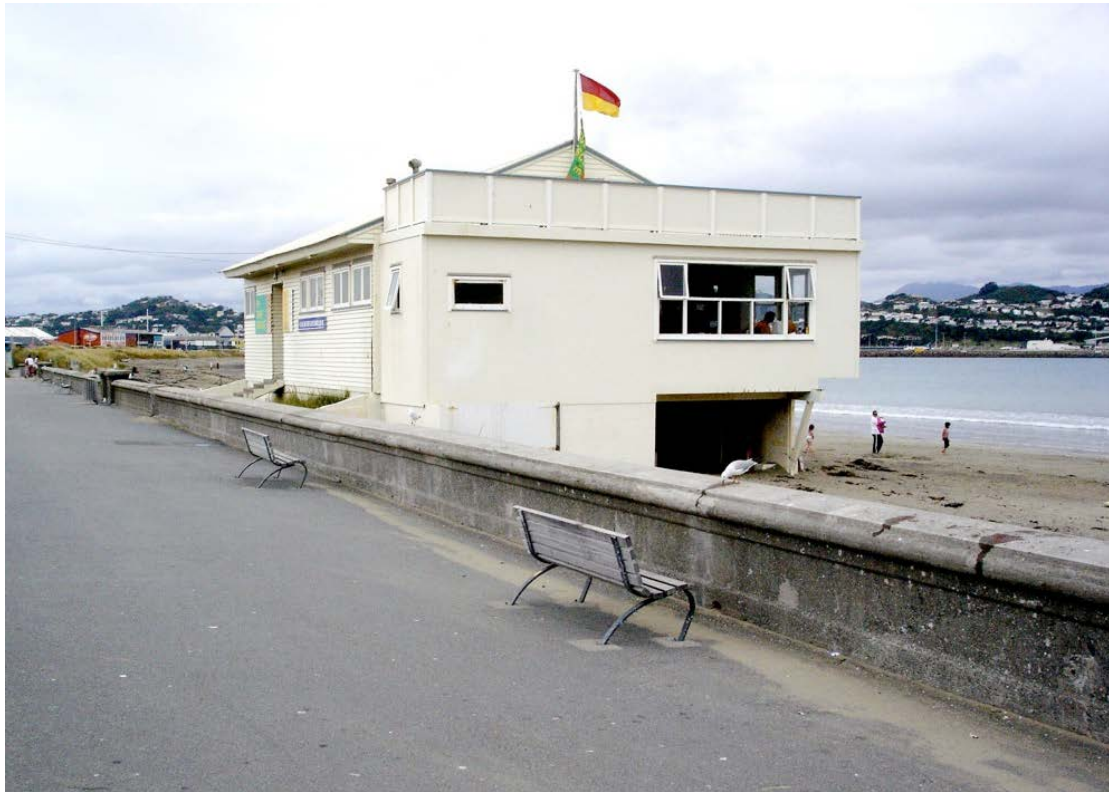
Lyll Bay Sea Wall (Photo: WCC, 2010)

The sea wall is a simple but elegant engineering structure designed to cope with the rigours of its extremely exposed location within a severe marine environment. Similar to a small-scale military defence, it presents an upswept glacis to the beach side, overtopped with a heavy moulded coping that serves to turn much of the sand and spray back to the beach; its height varies from less than a metre where the dunes have accumulated in front of it, to between two and three metres where there is little sand. The coping profile is mirrored on the pavement side, where the wall is generally less than a metre high. At the ends of the wall, the coping returns on itself to provide a simple and neat visual finish to the structure.⁶

The old wall runs between its end points in two major straight-line segments set tangentially to the arc of the bay. The wall is interrupted by evenly-spaced openings for the stairs to the beach, the entry points to which are delineated with pairs of squat pilasters, and by the series of cuts in the wall made for the four existing buildings on the beach – from east to west, the two Lyall Bay Surf Club buildings, the small “affordable arts” building, and the Maranui building. These cuts include:
